Manhole Inspection Summary

Manhole # S21C__018MH

Insp Date: **9/19/07 10:38 AM**

Location Address: **1700 MOUNT ST** Cross Street: **MULBERRY ST**

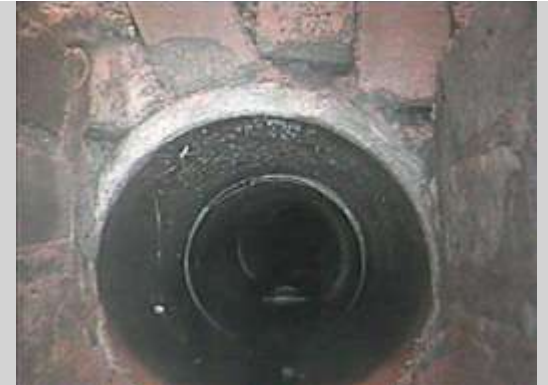
12 O'Clock Outflow

8 in. Circular Gravity Sewer
Pipe Out @ 12 O'Clock

Pipe Height: **8.4** (in.) Rod and Bar (Angled)
Pipe Material: **Clay** ☐ Pipe Lined
Invert Depth: **10.81** (ft.) Flow Characteristics: **None**
Deposits: ☒ None ☐ Mud ☐ Sludge ☐ **Debris** ☐ Grease
Silt Depth: (in.) Deposits Extent:
Infiltration: **None** Pipe Seal Cond: **Sound**
